# 2

## Existing and Future Transportation Conditions

This chapter summarizes the existing and potential station access conditions for the NJ 124 Corridor Transit Access Improvement Study including:

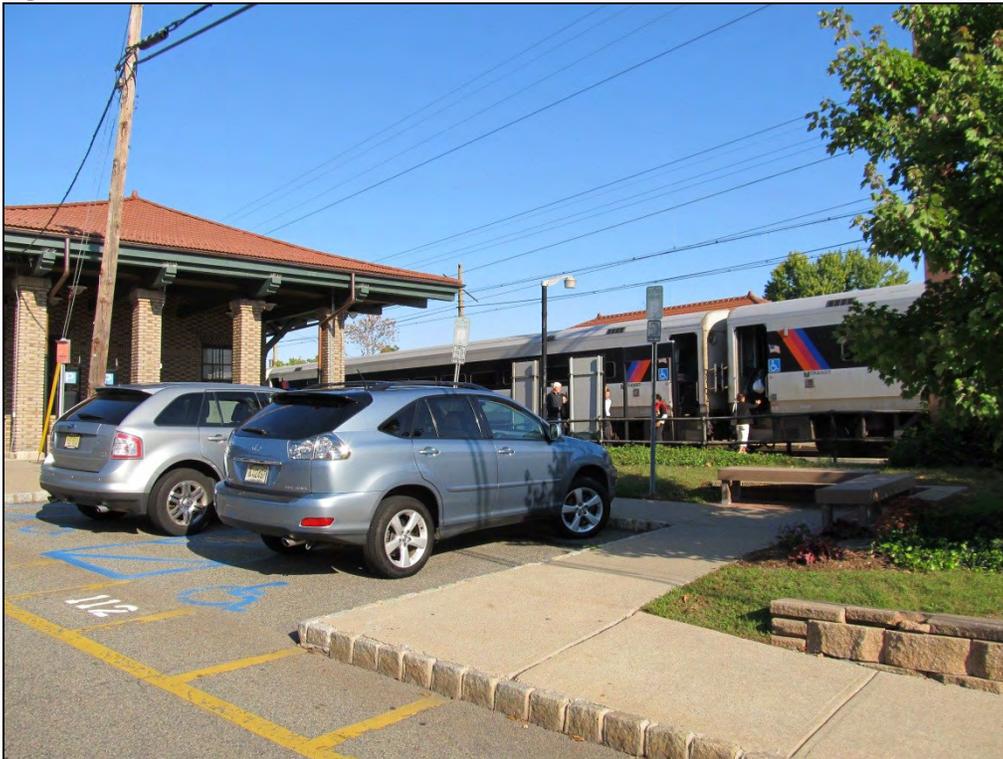
Figure 2-1: Chatham Station

- Chatham Station: Front Street between Fairmount and Washington Avenues (Figure 2-1)
- Madison Station: Kings Road between Prospect Street and Green Avenue/ Waverly Place (Figure 2-2)
- Convent Station: Convent Road and Old Turnpike Road (Figure 2-3)

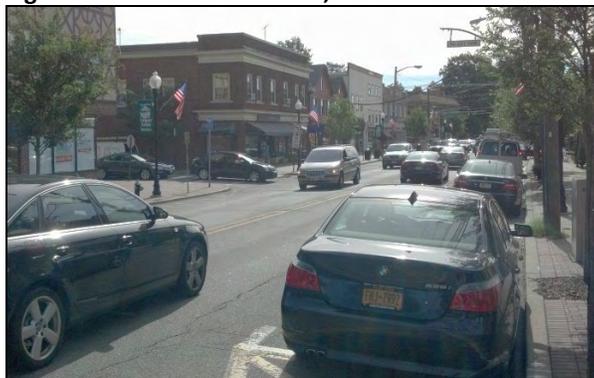
Figure 2-7: Eastbound NJ 124, East of Fairmount Avenue

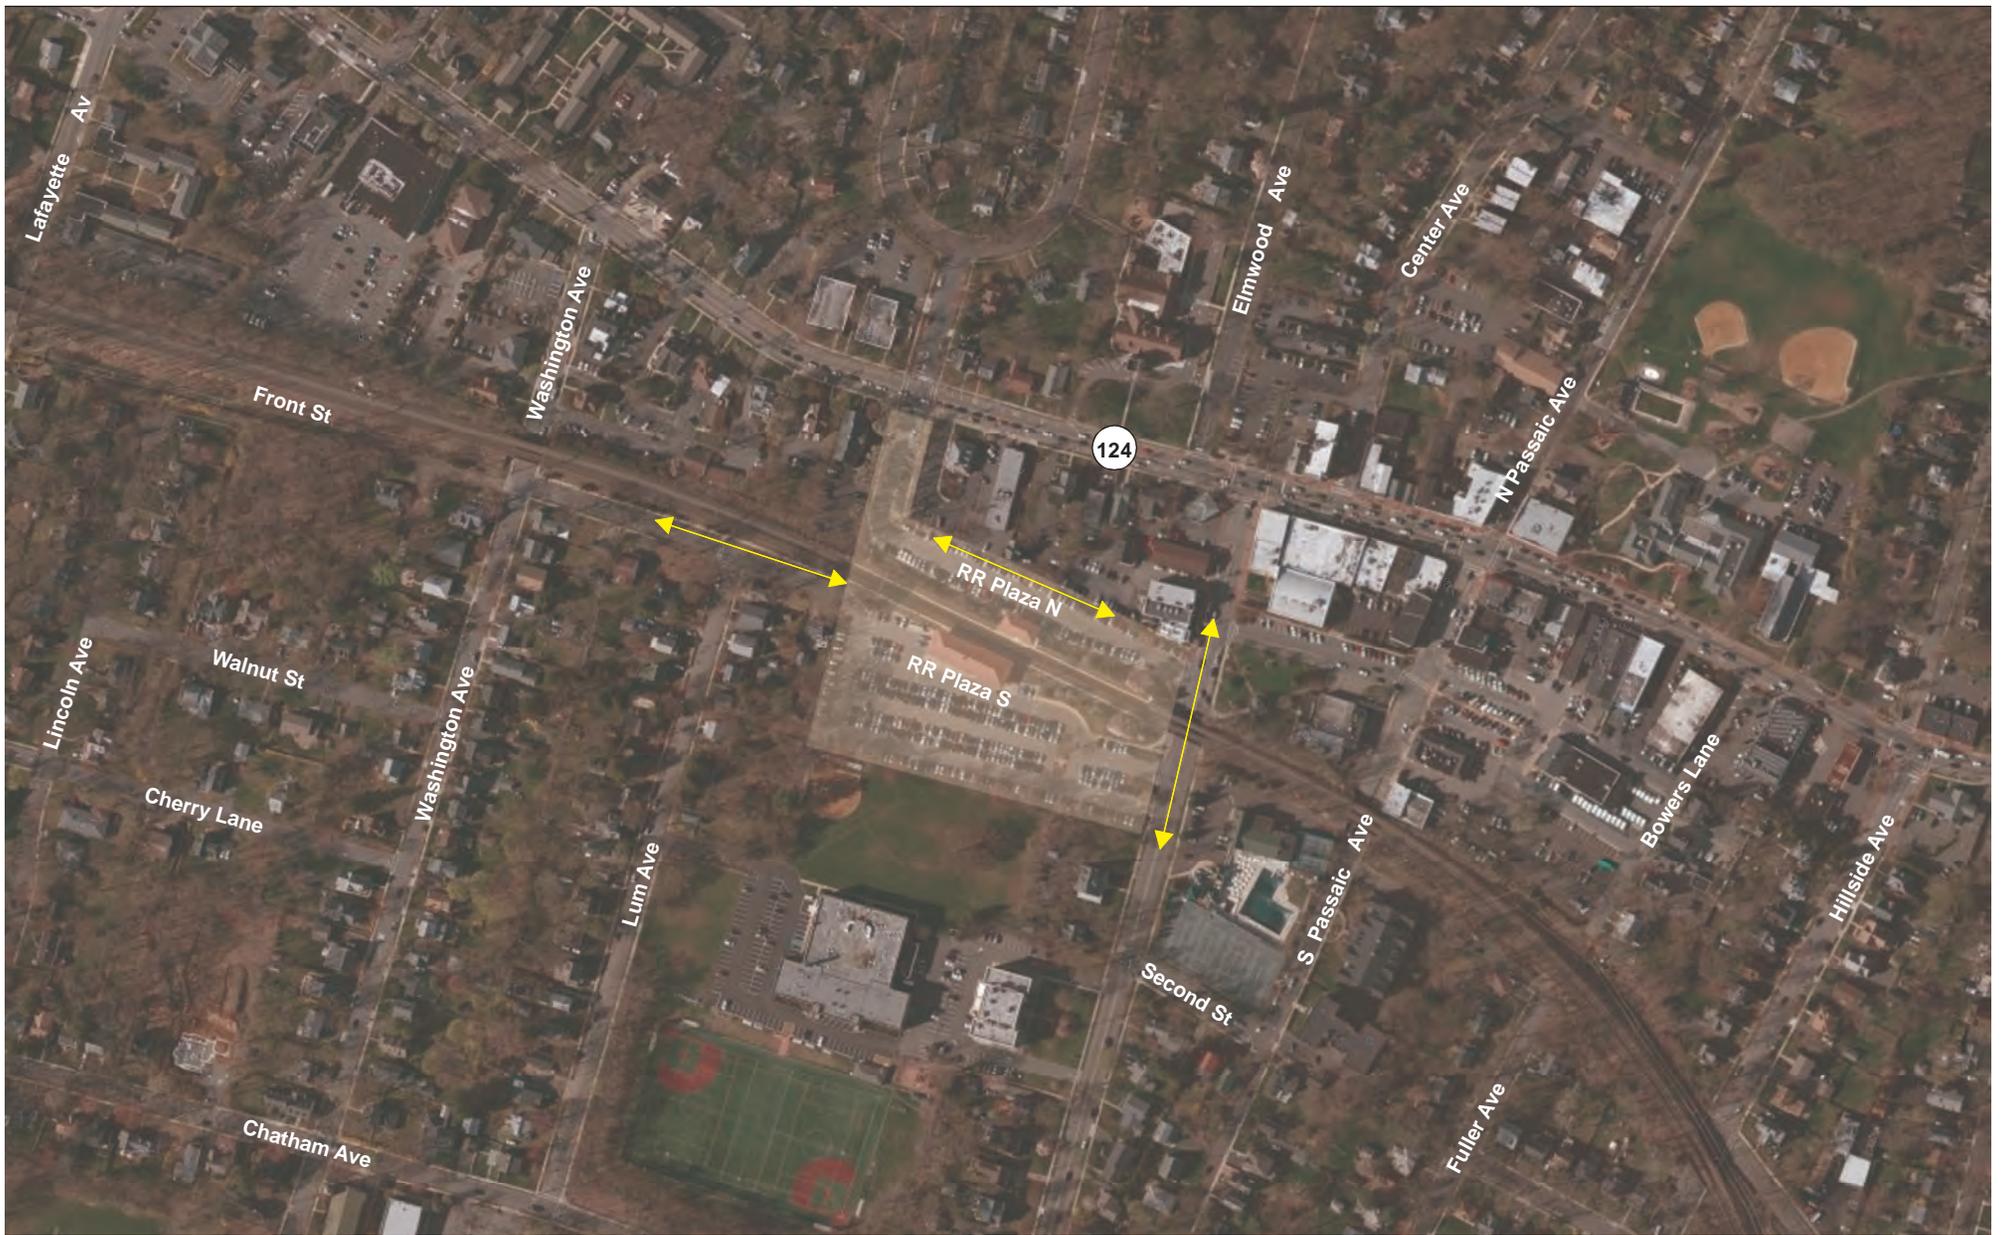
FIGURE 2-8

Chatham Station is accessed directly by three of these roadways, as shown in Figure 2-8: Fairmount Avenue, Railroad Plaza North, and Railroad Plaza South. Fairmount Avenue is designated as County Route 638, and carries one travel lane in each direction with restricted on-street parking on both sides. Fairmount Avenue is also the main access point to the commuter parking lot on the eastbound (south) platform of the station. Railroad Plaza South is a narrow street with a 26-foot right-of-way and no parking, used primarily by the residents of that neighborhood to access the station. Railroad Plaza North is a somewhat wider street at about 50 feet, which serves as access to the westbound (north) platform of the station. This street contains daily and permit parking spaces on both sides of the road.

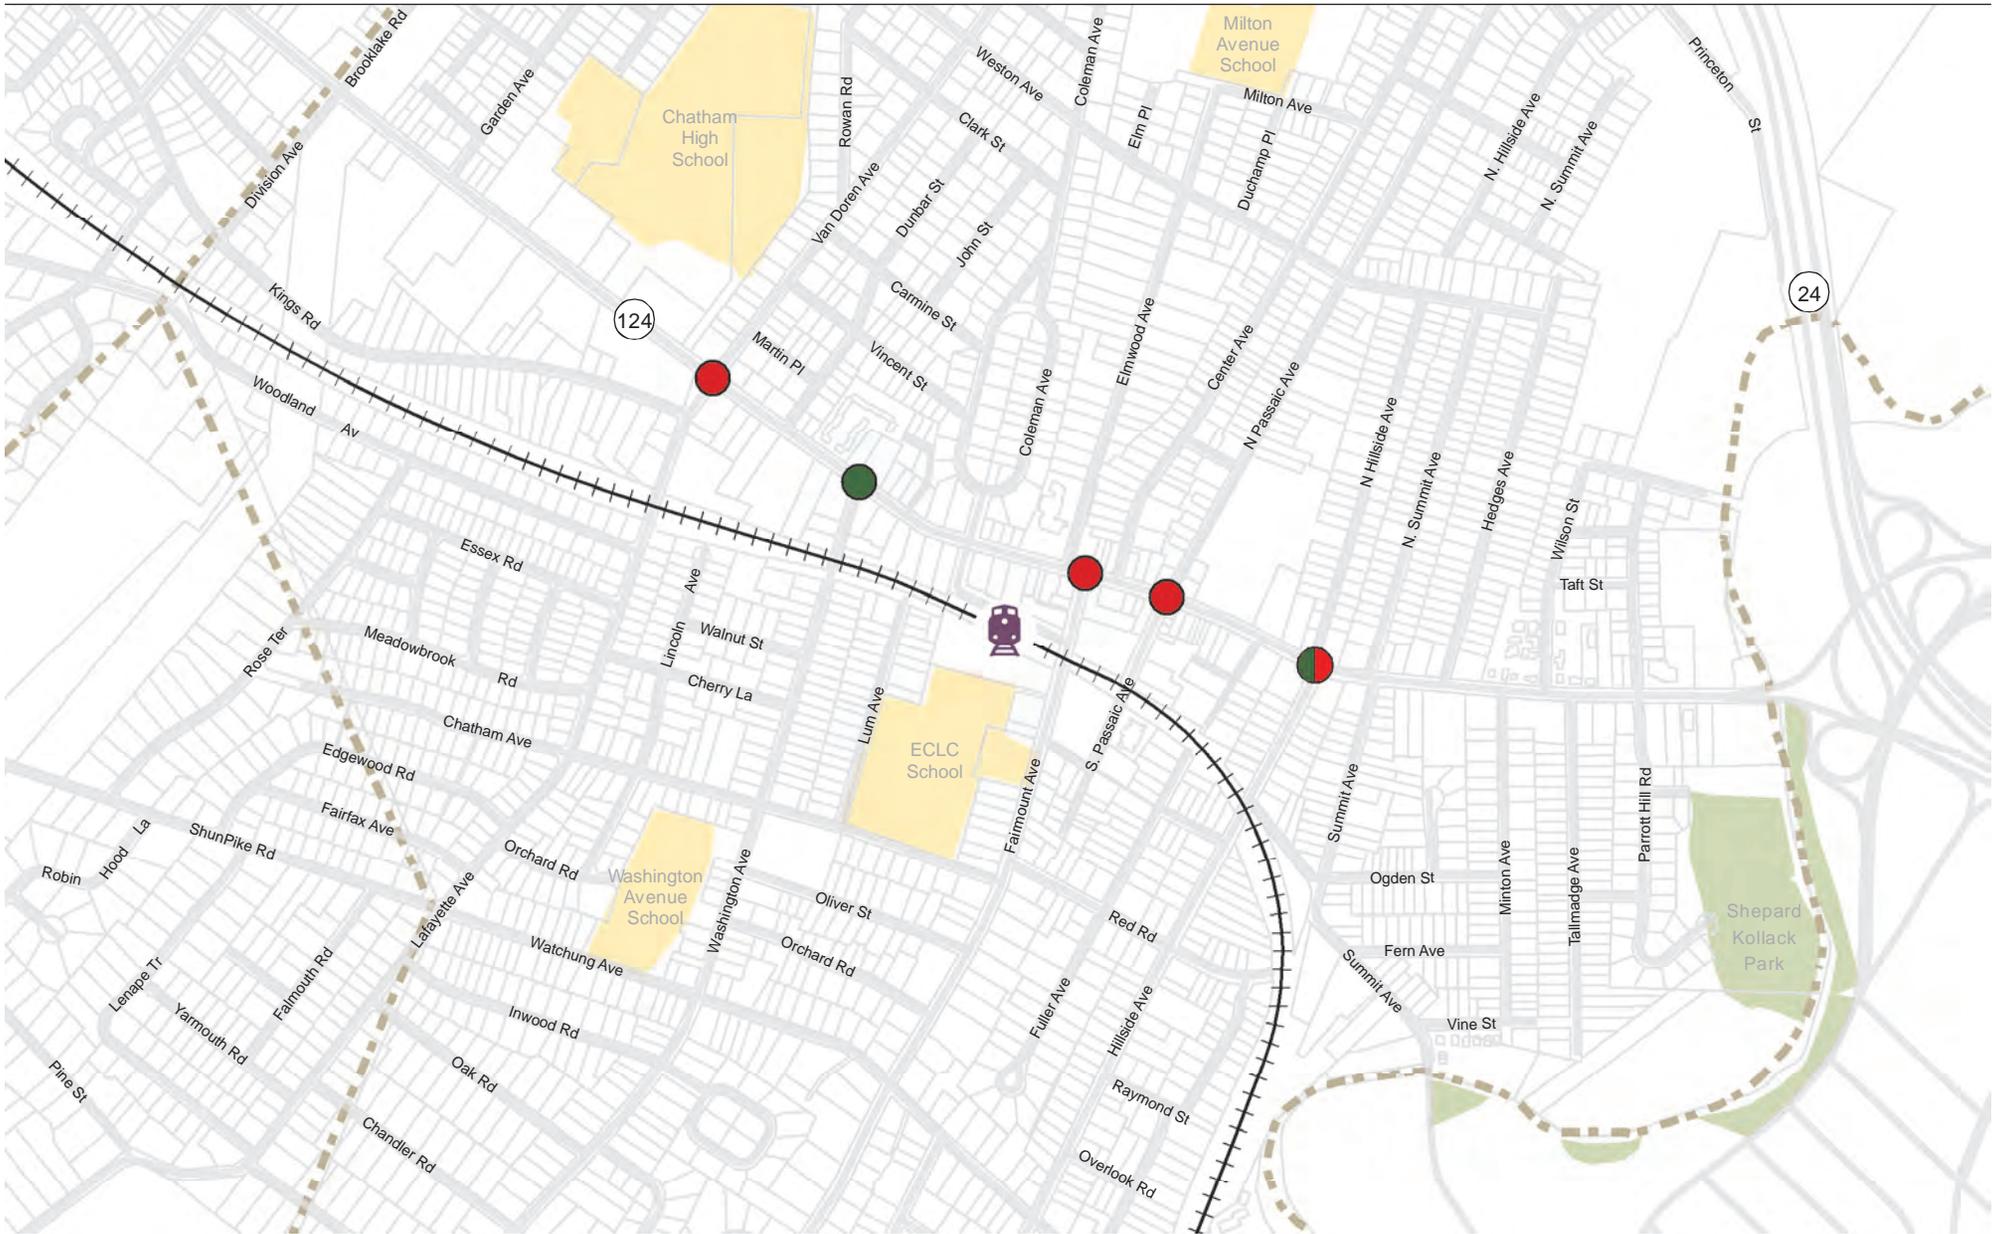
Currently, the intersections of Passaic Avenue, Fairmount Avenue, and Lafayette Avenue along NJ 124 are congested in both the AM and PM peak periods, as shown in Figure 2-9. This congestion is caused by high vehicular traffic volumes and long queuing on the local streets related to parking maneuvers and left-turning vehicles. Since this area has a narrow right-of-way along NJ 124, there is currently no striping for dedicated left turn lanes along NJ 124. At one intersection (Passaic Avenue), a dedicated lead green phase on the southbound Passaic Avenue approach allows traffic from Passaic Avenue to turn left onto eastbound NJ 124. There is no dedicated left turn lane at this approach, however.

*Congested intersections have a Level of Service of D, E, or F as reported in the 2010 Exxon Site Report.*

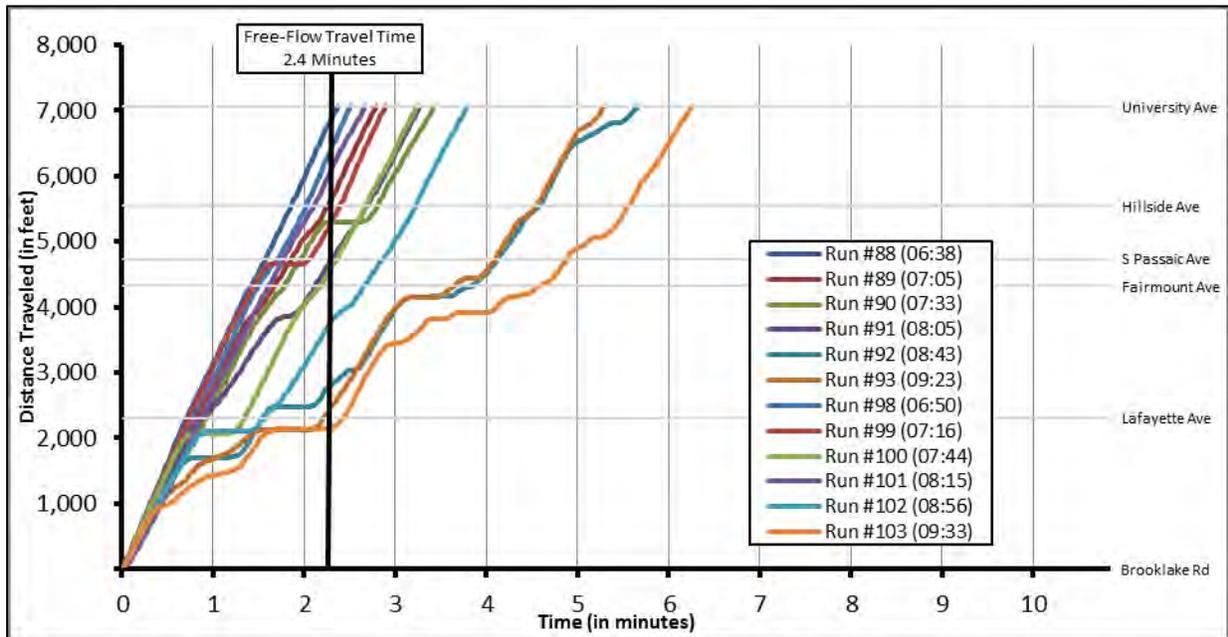
Figure 2-10: NJ 124 Eastbound Travel Times Runs - AM Peak

The “Free-Flow Travel Time” of this corridor serves as a baseline for comparing individual runs; eastbound and westbound progression is around 2.4 minutes. Average travel times in the eastbound direction range from 2.4 to 6 minutes in the AM peak and 3.5 to 9.5 minutes in the PM peak. The westbound travel times range from 2.4 to 9.4 minutes in the AM peak, while the PM peak has a narrower range of 4 to 5.5 minutes.

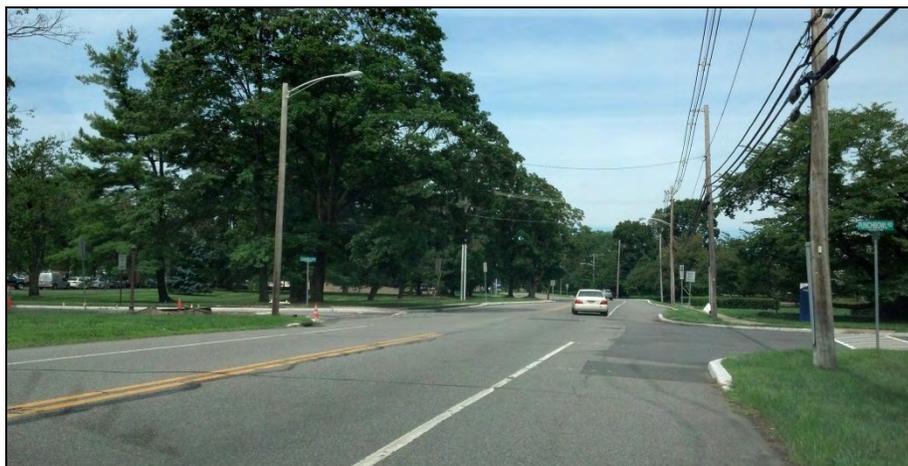
**Figure 2-24: Westbound NJ 124, east of Punch Bowl Road**

Generally, most of the Morris Township intersections operate at acceptable levels of service. As noted in the 2010 Exxon Site report, several movements at the unsignalized intersection of NJ 124 and Punch Bowl Road exceed capacity and queue lengths. This intersection also has heavy eastbound left-turning traffic from NJ 124 onto Punch Bowl Road in the AM peak period, which causes sudden stops and unsafe maneuvers (see Figure 2-24).

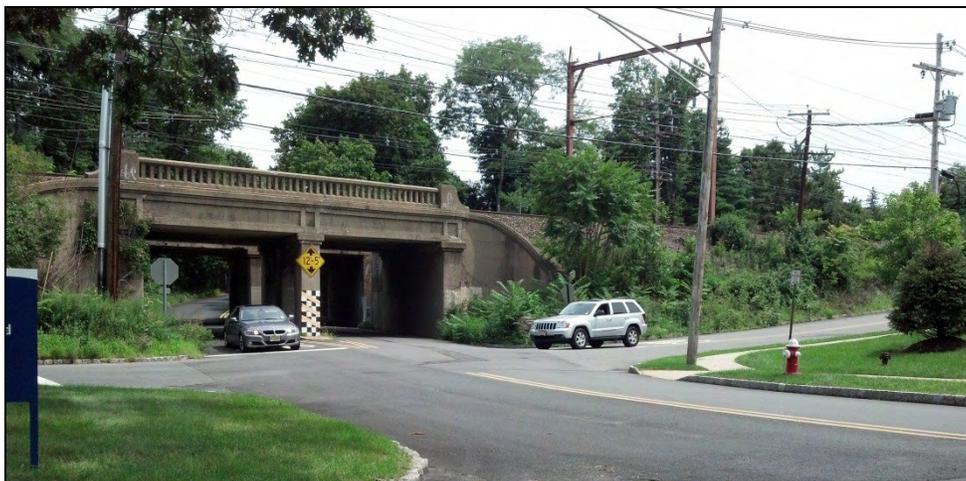
**Figure 2-31: Westbound Punch Bowl Road, West of Old Turnpike Road**

The intersections along NJ 124 between Franklin Street and Dodge Drive are typically congested during evening peak periods, as well as on weekends. As shown in Figure 2-31, the intersection of Old Turnpike Road and Punch Bowl Road is currently a three-way stop controlled intersection that has inadequate sight-distance underneath the rail bridge.

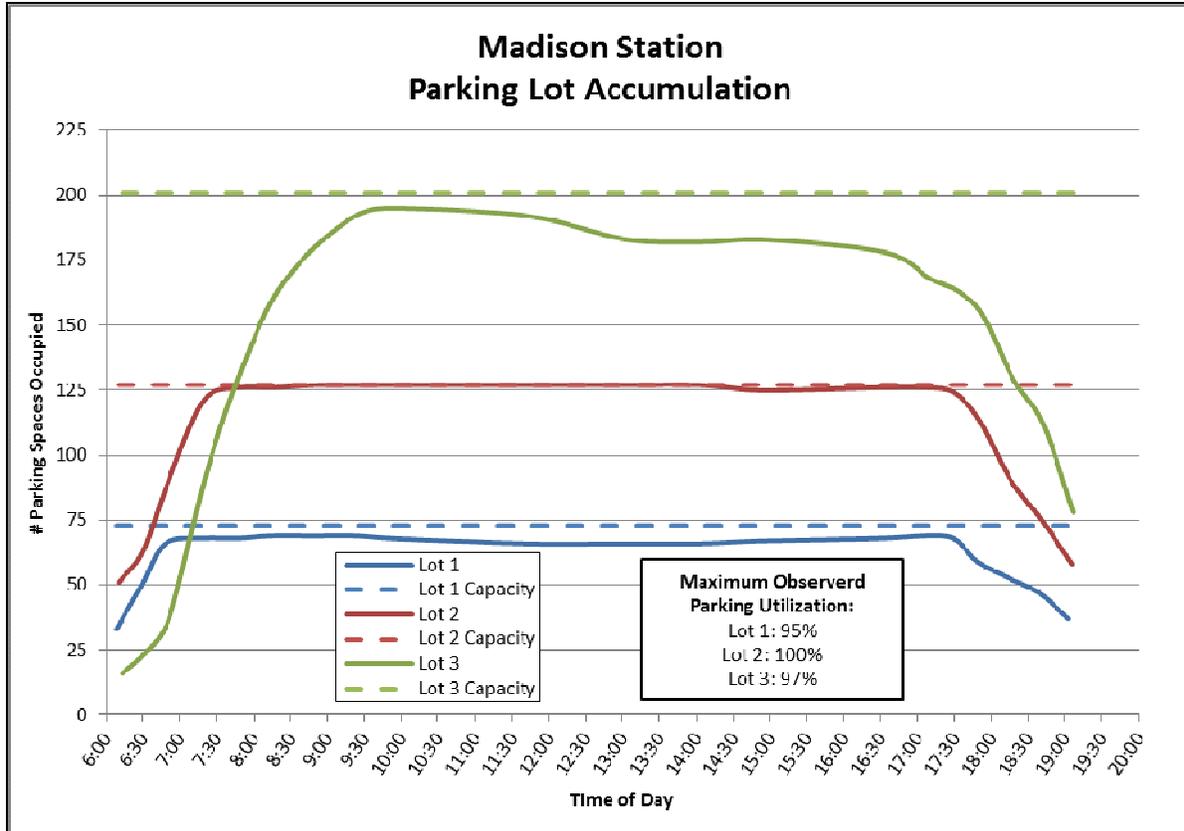
Figure 2-35: Madison Train Station Parking Accumulation Profiles

Parking accumulation profiles for the three Madison commuter lots from 6:00 AM to 7:30 PM are shown in Figure 2-35. Lots 1 and 2 (dedicated to train commuters) were consistently close to capacity for the majority of the day, whereas the utilization of Lot 3 declined slightly after 1:00 PM. Daily spaces filled earliest, since most of them are located closest to the station and the quantity of these spaces is more limited. The peak utilization rate observed for the lots ranged from 95 percent to 100 percent. Lot 1 was not at 100 percent capacity due to vacant handicap spaces. Lot 3 shows had a high percentage of turnovers mainly due to vehicles parked for local businesses. Lots 1 and 2 had a number of spaces filled by 6:00 AM, while peak activity at Lot 3 began at around 7:00 AM. The eight ADA spaces in Lot 1 were about half full throughout the duration of the day.

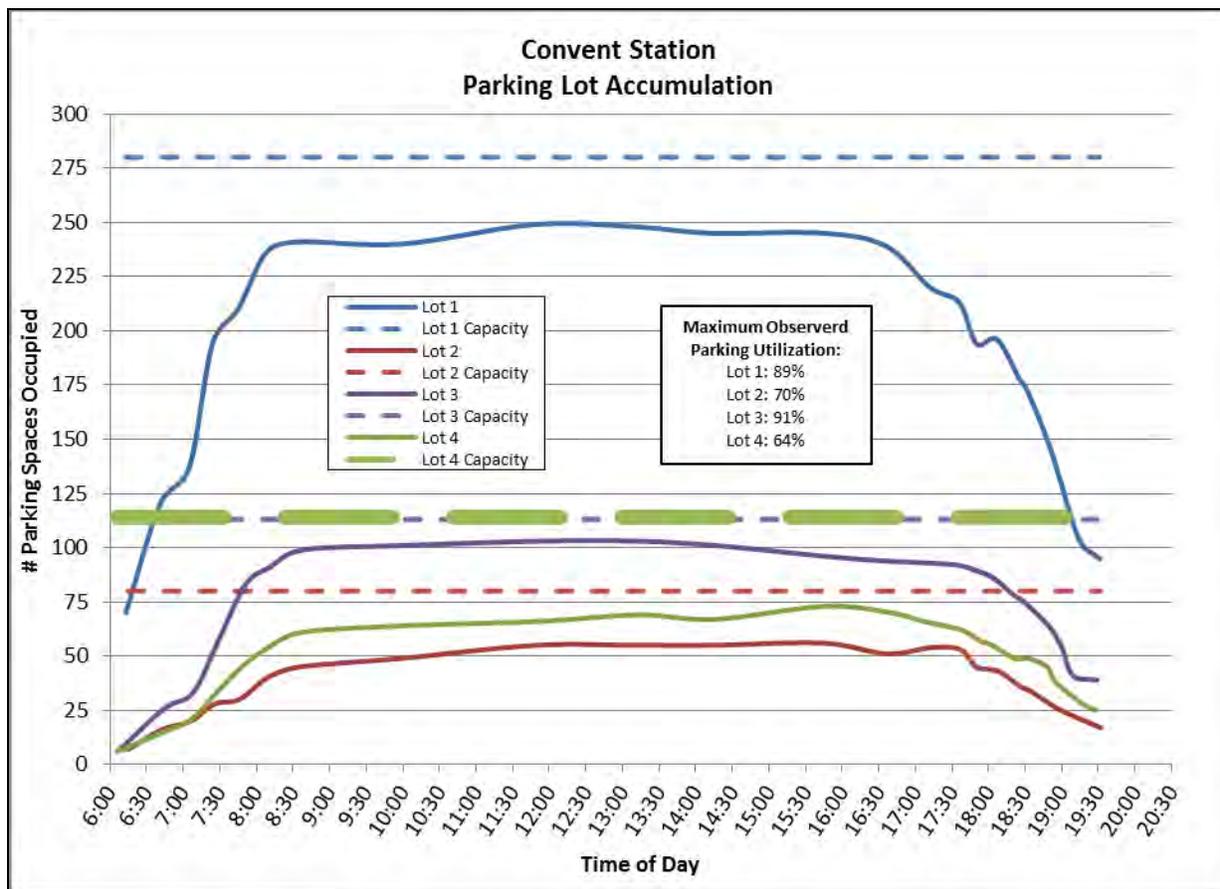
Figure 2-37: Convent Train Station Parking Accumulation Profiles

The parking accumulation profiles for the four Convent Station lots from 6:00 AM to 8:00 PM are shown in Figure 2-37, with detailed utilization and duration information for the 53 sample spaces shown in Table 2-21. The peak utilization observed for the lots ranged from 64 to 91 percent, with Lots 3 and 4 having the lowest and highest peak occupancy, respectively. During the survey numerous vehicles were observed entering Lots 3 and 4 around 4:00 PM. These were not rail customers but instead were parking to play on the soccer field. These vehicles parked in any open parking space, both permit and daily, and did not pay, even though regulations state that there is only free parking after 6:00 PM.

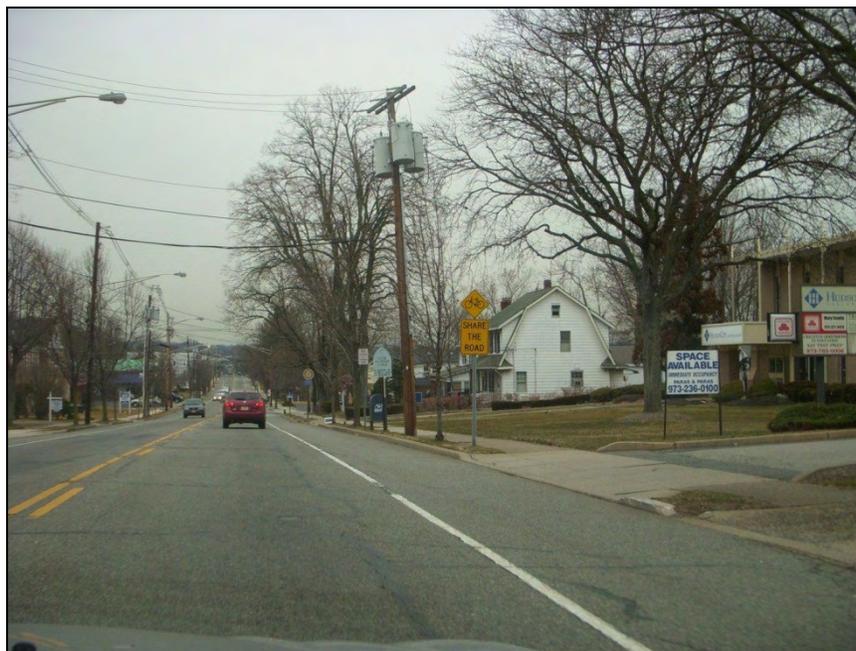
Within Chatham Borough there are no signs or markings for any bicycle routes. However, there is some signage on the border of Chatham Borough and Madison (see Figure 2-42). The *Morris County Bicycle & Pedestrian User Guide* from 2004 shows two roadways, Fairmount (CR 638) and Watchung (CR 646) Avenues, as shared bicycle/ vehicle facilities, and identifies NJ 124 as a bicycle route. However, no signage to this effect was observed along these roads. Fairmount Avenue is the primary access roadway to Chatham Station and NJ 124 has shoulders outside of the downtown area that are generally wide enough to accommodate bicyclists.

Figure 2-42: Share the Road Signage on Westbound NJ 124 at Division Avenue/Brooklake Road

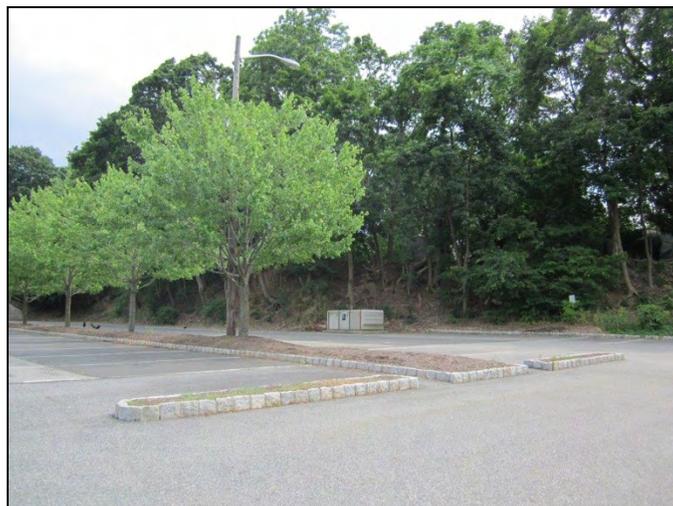
The bicycle lockers are not located at the station, but in the Kings Road parking lot south of Prospect Street (Figure 2-44). According to TransOptions, as of January 2012, three of the six lockers were rented (additional information received in June 2012 shows five of the six lockers rented). Fees for lockers are the same as at Chatham Station. The remote location may discourage use and may be the reason why Madison Station, which is much busier than Chatham Station, has 10 fewer lockers.

**Figure 2-44: Remote Madison Station Bicycle Lockers in the King Street Lot**

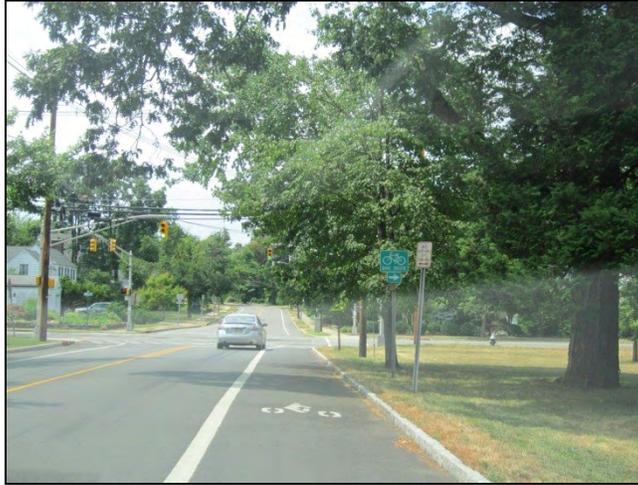
The Woodland Avenue bicycle lanes appear to be relatively new and provide an example of easy-to-see bicycle stencil street markings (Figure 2-46). It is important that drivers can see the markings so they are aware this is a bicycle route.

**Figure 2-46: Visible Bicycle Stencil and Sign on Westbound Woodland Avenue at Green Avenue**

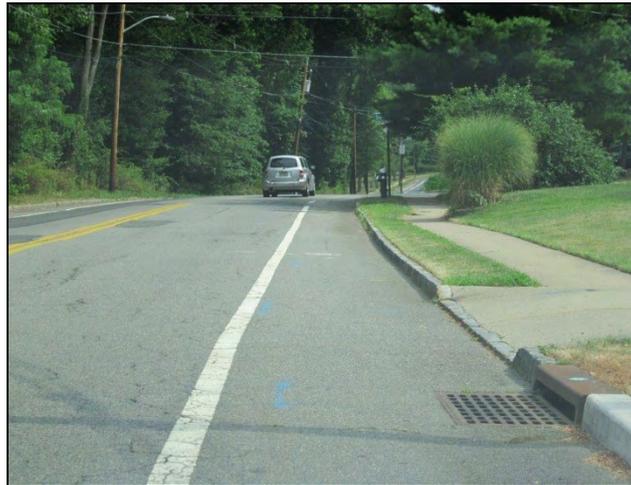
Figure 2-47 shows a bicycle stencil on Rosedale Avenue. From the driver's perspective, the stencil is nearly invisible; the driver is not aware this is a bicycle route.

**Figure 2-47: Southbound Rosedale Avenue Bicycle Marking is Barely Visible**

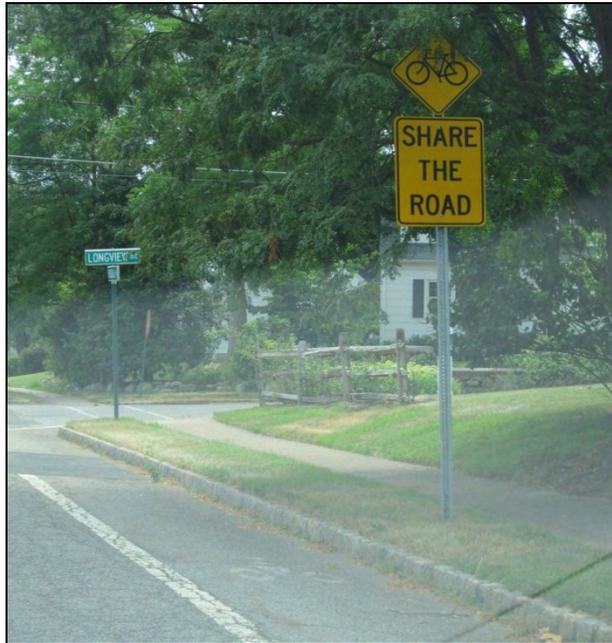
The photo below (Figure 2-48) shows a Share the Road sign and a bicycle stencil, but the stencil is not visible until the car is next to the sign, and the sign is obscured by trees.

**Figure 2-48: Southbound Rosedale Avenue Bicycle Facility**

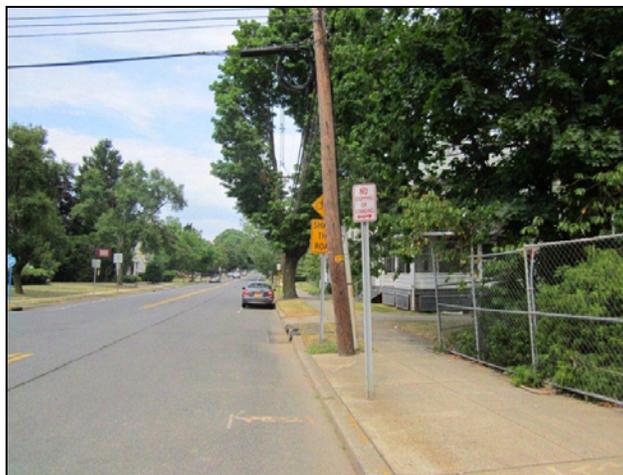
This example (Figure 2-49) from northbound Greenwood Avenue illustrates poor placement of a Share the Road sign immediately behind a telephone pole. It is not visible to the drivers that it intends to inform. Bicyclists share the road with vehicles, but also contend with curbside parking as shown in the photo.

**Figure 2-49: Poor Placement of Share the Road Sign on Northbound Greenwood Avenue**

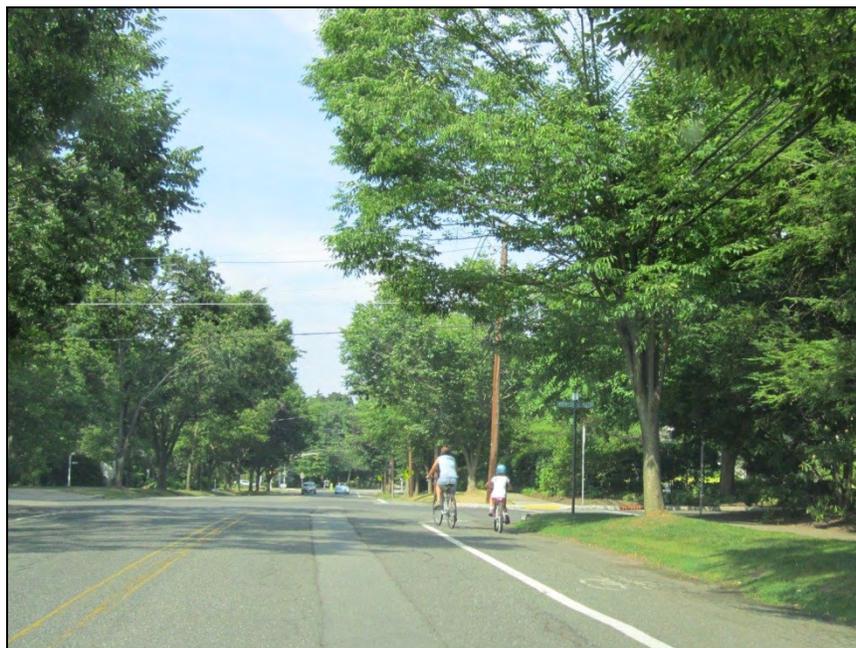
Despite these examples of improvements that are needed within Madison Borough, the municipality’s efforts have been beneficial in encouraging bicycle use. Figure 2-50 highlights bicycle usage on Green Avenue. A mother and child riding together in an on-street bicycle lane (as faint as the bicycle stencil may be), is an excellent indicator this bicycle lane is perceived as useful and safe by area residents.

**Figure 2-50: Mother and Child Bike Riding on Northbound Green Avenue**

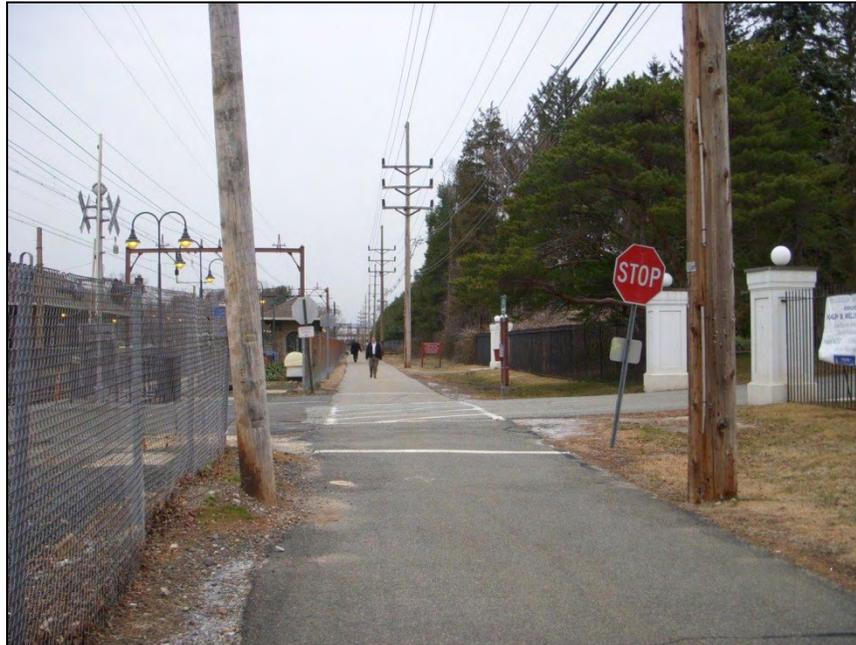
One multi-use (bicycle and pedestrian) paved trail is located near Convent Station. The Traction Line Recreation Trail connects directly to the Convent Station and abuts the adjacent Liberty Greens townhouse residential development, and is located parallel to and north of the tracks (Figure 2-53). This 3.2 mile long path stretches from Morristown (Morris Avenue just east of I-287) to the intersection of Danforth Road and Dreyfuss Road within Madison. The trail covers about half of the distance between Convent and Madison train stations. An extension of the Traction Line Recreation Trail from Danforth Road to Elm Street (about 0.6 mile) in Madison is currently being planned by the Morris County Parks Commission.<sup>14</sup> This extension would not reach the Madison Station, but would close a portion of the gap. Comments received from stakeholders include the need to eliminate or ease the stairway along the Traction Line at Normandy Parkway, northwest of Convent Station, because it requires riders to dismount and carry their bicycles. The addition of a channel (see Figure 5-21 in Chapter 5) that runs along the stairway allowing a bicyclist to push the bicycle up and down the stairs was suggested.

**Figure 2-53: Traction Line Trail at Convent Road Grade Crossing at Convent Station**

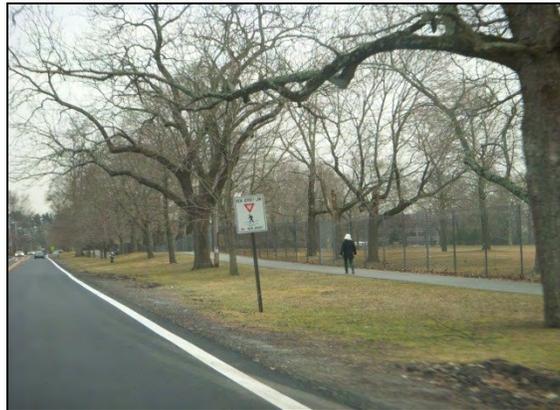
around Giralda Farms, but no indication of a formal name was found. This trail heads southeast, paralleling NJ 124 (Figure 2-55), then south along Loantaka Way toward the Loantaka Brook Reservation. This path could connect residential neighborhoods to NJ 124 and the Convent and Madison Stations. The trail is located within the Borough of Madison; however it is more proximate to the Convent Station.

**Figure 2-55: Multi-Use Trail along the South Side of NJ 124**

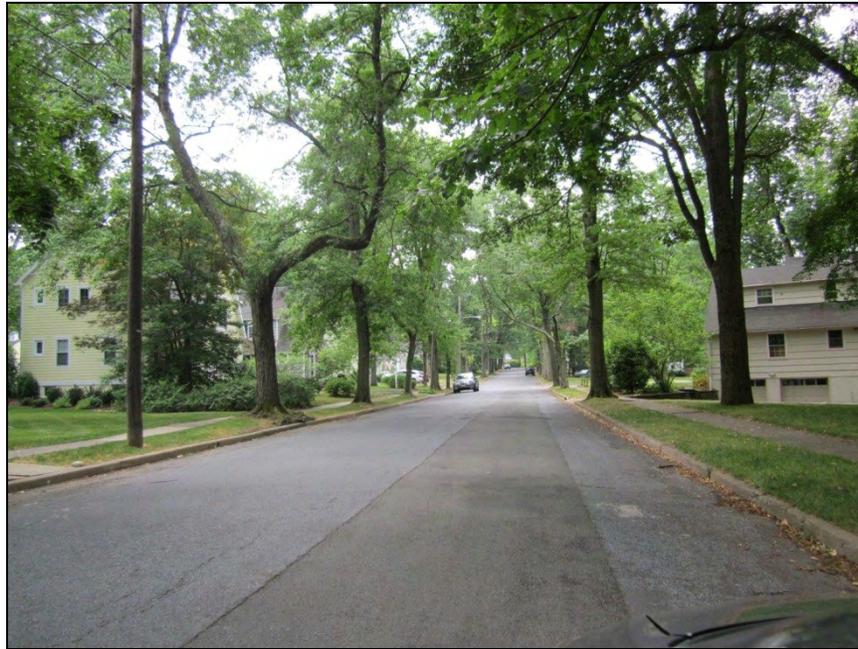
Some streets create ideal pedestrian environments, as shown in the pictures below. Coleman Avenue (Figure 2-57) is an example of a wider street with sidewalks and trees that makes for a welcoming walking environment. Essex Road (Figure 2-58), with a basketball hoop on the shoulder, does not provide sidewalks but is generally safe for play and walking due to low traffic. Nevertheless, it is important to note that many neighborhood streets are not lit, so some may find walking during early morning and evening hours difficult.

Figure 2-57: Ideal Pedestrian Environment-Southbound Coleman Avenue at Weston Avenue

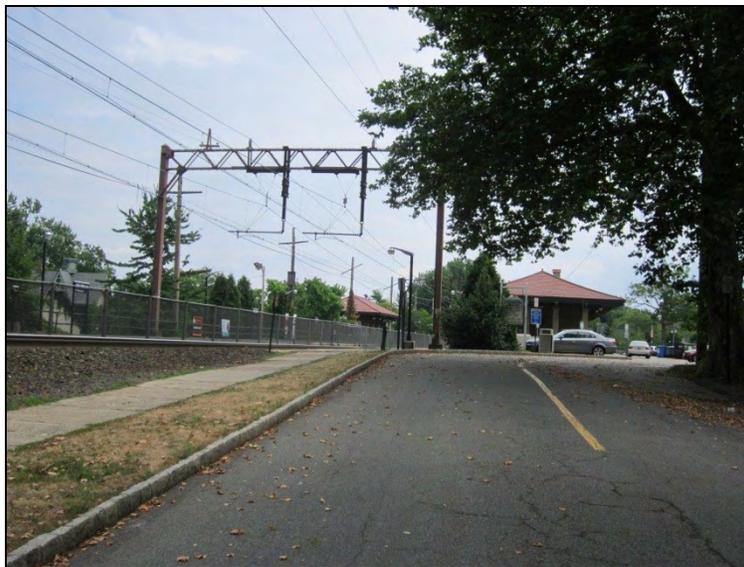
**Figure 2-59: Sidewalk to Chatham Station along Front Street**

Although Chatham Station is generally pedestrian accessible (Figure 2-59), with sidewalks connecting to it from all sides, there are one or two exceptions. One gap in this connection is the lack of crosswalks at the intersection of NJ 124/ Main Street and Washington Avenue. This intersection provides residents of neighborhoods to the northwest of NJ 124 access to the station. The intersection of Coleman Avenue and NJ 124 is a heavy crossing point to access the station, and pedestrian activated flashing signals (Figure 2-60) have been installed to alert motorists of pedestrian crossings. Comments from stakeholders noted that there are many pedestrians that cross here in the evenings and that even the flashing signal can seem inadequate. The police department and NJDOT are evaluating if this location may meet a traffic signal warrant, which could improve pedestrian crossing safety<sup>15</sup>.

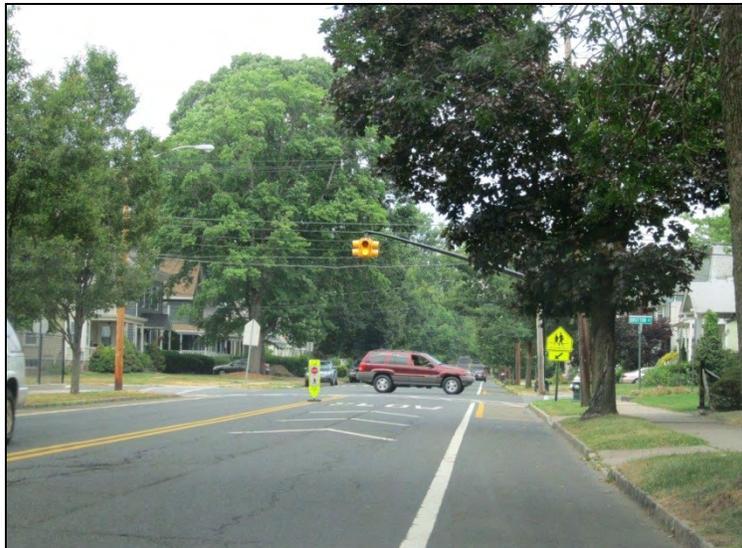
**Figure 2-63: Pedestrian Crossing Safety Items at Greenwood Avenue Northbound at Brittin Street**

On Greenwood Avenue, near the Central Avenue School athletic fields and a playground, the crosswalks are illuminated by an overhead flashing signal, a bright yellow “Safe Routes to School” sign, a “stop for a pedestrian in the crosswalk” signage, and a “Slow” markings with chevrons (Figure 2-63).

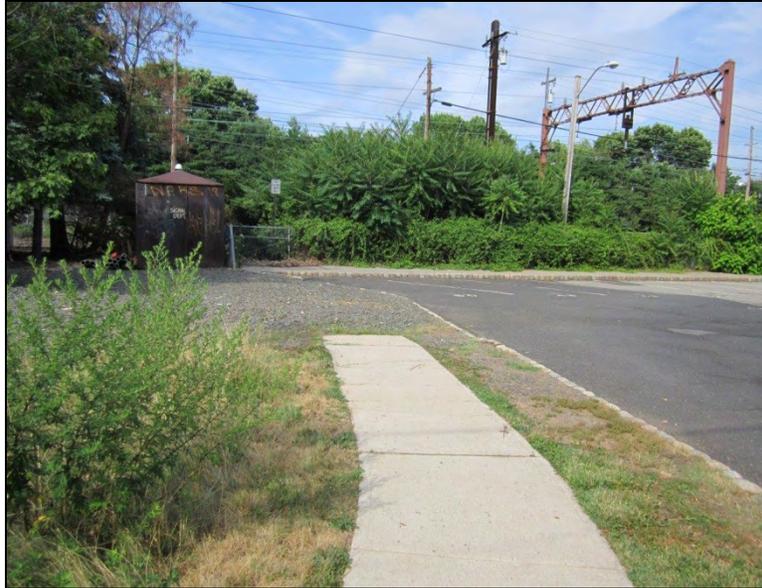
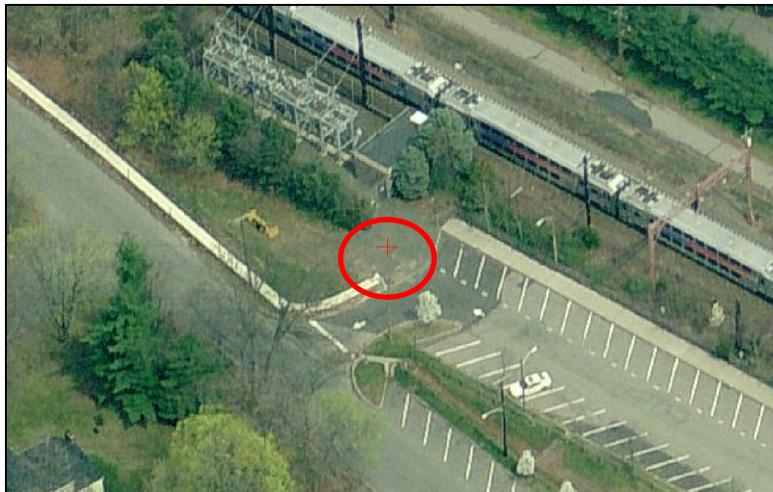
Figure 2-67a: Old Turnpike Road Sidewalk to Convent Station

There are generally few pedestrian amenities in the area. There are almost no sidewalks located within a half mile of the station, with the exception of around particular housing or corporate developments. In the low density residential neighborhoods south of NJ 124, sidewalks are not required. With little vehicular traffic, walking can still be safe in these neighborhoods. One exception is the sidewalk extending along Old Turnpike Road from Punch Bowl Road to the west end of the station parking lot. This sidewalk is located mostly adjacent to the rail right of way. There is a gap in the sidewalk as it crosses an unpaved driveway. Continuing the sidewalk across the driveway would enable pedestrians to connect directly to the station without being forced to walk (Figures 2-67a and 2-67b) through the parking lot to the station.

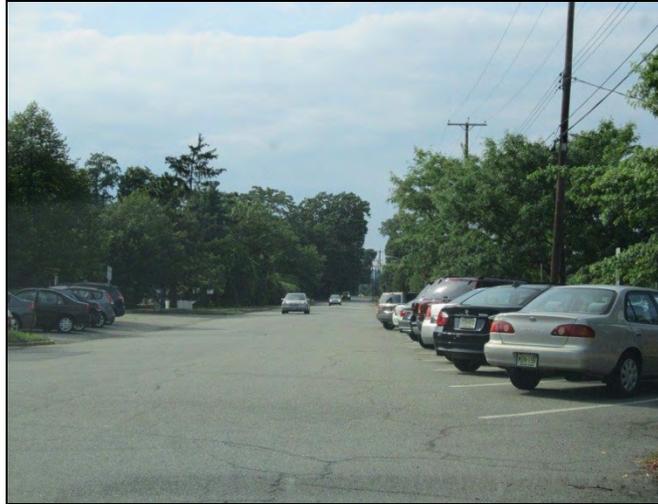
**Figure 2-68: Westbound on Old Turnpike Road from Convent Road**

Old Turnpike Road near Convent Road is an unwelcoming street to pedestrians. With no sidewalk, pedestrians are required to walk behind parked cars (note the worn pedestrian path 2-67b). Public comments received suggested this roadway be improved for both pedestrians and bicyclists (Figure 2-68).

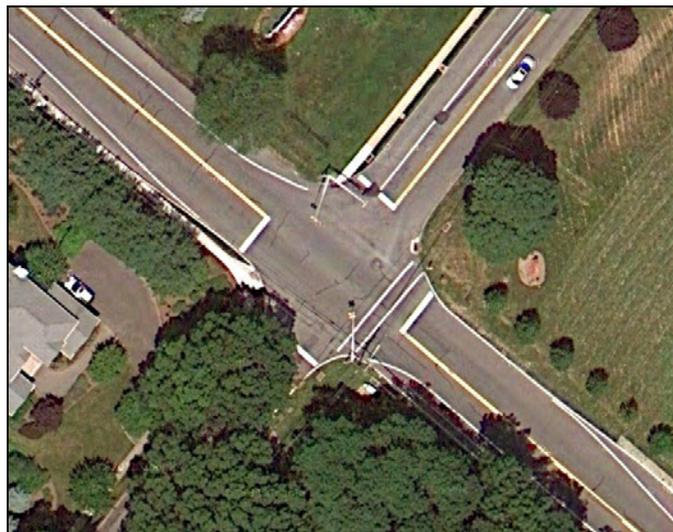
At the intersection of NJ 124 and Convent Road/ Canfield Road there is a pedestrian crossing across NJ 124. This location, however, illustrates the lack of planning that has occurred. As shown in Figures 2-69 and 2-70, the crosswalk across NJ 124 is located on the southeast side of the intersection, whereas the sidewalk along Convent Road is located on the opposite side of the street. Although there are few walkers in the area, correction of these types of mistakes would improve pedestrian access to Convent Station.

**Figure 2-69: Mismatched Crosswalk and Sidewalk at Intersection of NJ 124 and Convent Road**

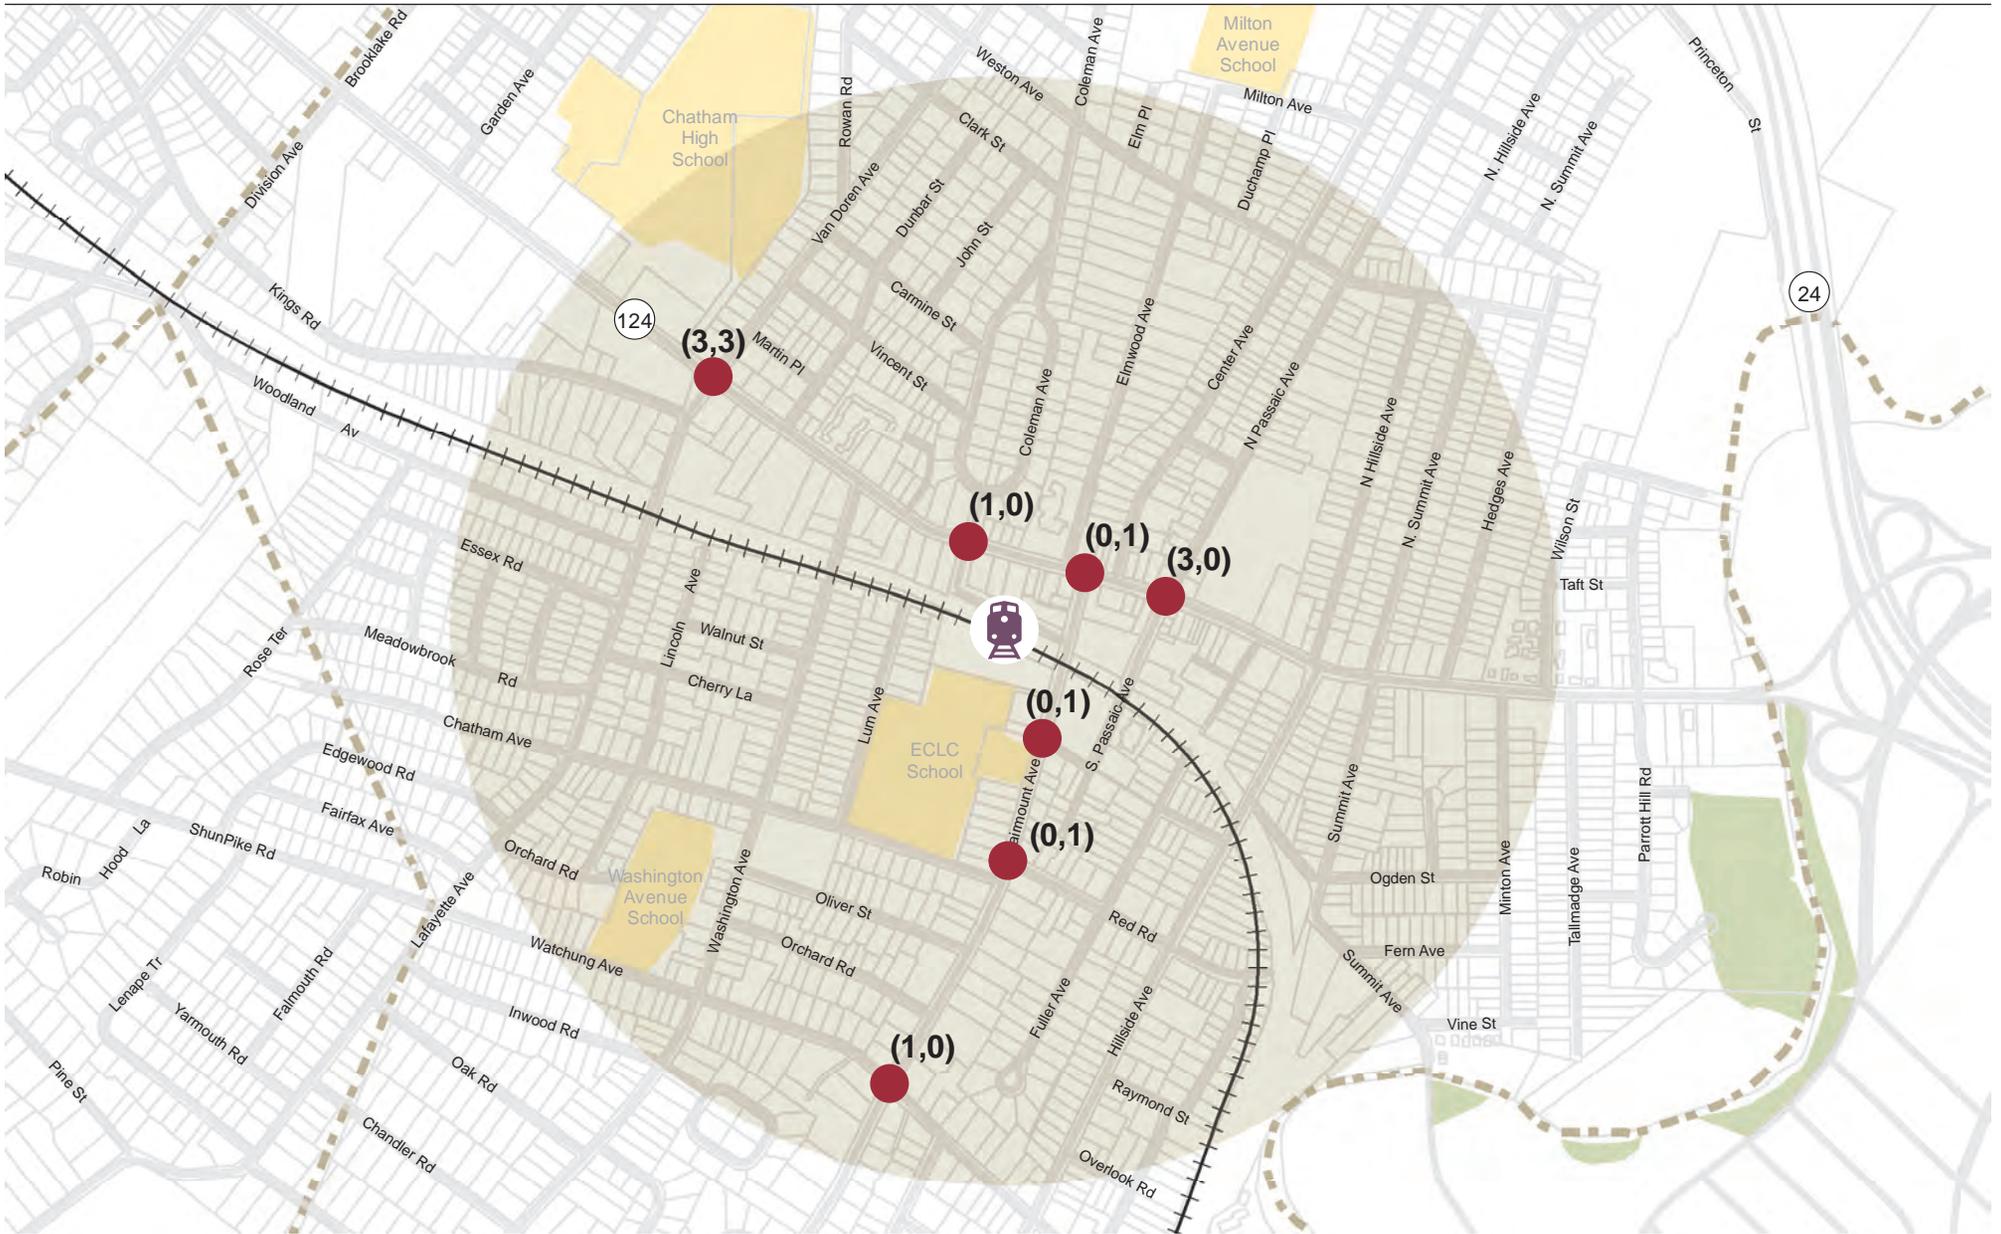
**Chatham Station  
Pedestrian and Bicycle  
Crashes**  
FIGURE 2-73

Within a half mile of Chatham Station, there were eight pedestrian crashes and eight bicycle crashes in the five year study period (See Figure 2-73: Chatham Station Area Pedestrian and Bicycle Crash Location Map). There were no fatalities, but six of the eight pedestrian crashes and seven of the eight bicycle crashes involved injuries. Five of eight pedestrian and seven of eight bicycle crashes occurred at intersections. For reference, pedestrian and bicycle crash data were analyzed near six NJ TRANSIT stations in the FTA research paper titled “Evaluation of Pedestrian Improvements in the Vicinity of New Jersey Transit Rail Stations” by Brian N. Tobin, et al, using 2005-2008 crash data within 0.15-miles of stations, and Chatham Station had the fewest crashes. In this paper, Bay Street, Roselle Park, Chatham, Brick Church, Woodbridge, and Millburn Stations were compared, wherein Bay Street had 10 crashes, Roselle Park had one, Chatham had zero, Brick Church had 35, Woodbridge had five, and Millburn had 20. Therefore, the eight pedestrian and eight bicycle crashes within a half mile of Chatham over a period two years longer and an area much broader likely shows that crashes in and around Chatham Station appear to be fewer than at other nearby typical NJ TRANSIT stations. Pedestrian and bicycle crashes within a half mile of Chatham Station were concentrated along the NJ 124 and Fairmont Avenue corridors. Locations on NJ 124 included Lafayette/ Van Doren Avenue, Fairmont Avenue, Coleman Avenue, and Passaic Avenue. Fairmont Avenue locations included Watchung Avenue, Red Road, and Second Street. There was also one pedestrian crash at North Passaic Avenue (CR 607) and Weston Avenue.
